# QS3 & Henning Sensor Suite

## ***Acceleration Measurement in all 3-axes***

***Design for  
modern elevator  
Diagnosis***

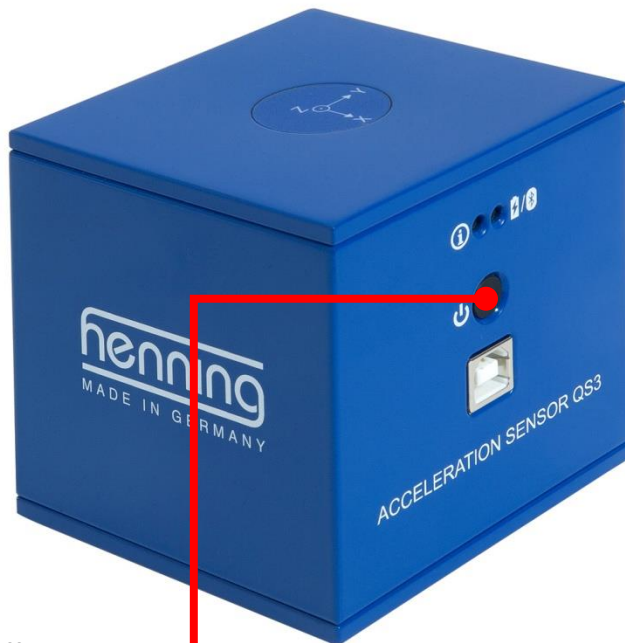
## Stand-Alone:

- 1. Start the sensor:**  
Push the black button once  
=> LED starts blinking green
- 2. Start the measurement**  
Push the black button again  
=> green LED stays on
- 3. Stop the measurement**  
Push the black button again  
=> LED starts blinking green
- 4. Download and Evaluation via PC**

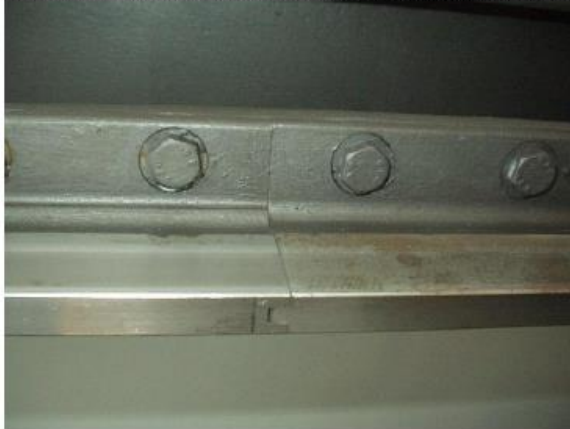
Die Schienen wurde offensichtlich aus zwei sehr unterschiedlichen Chargen montiert

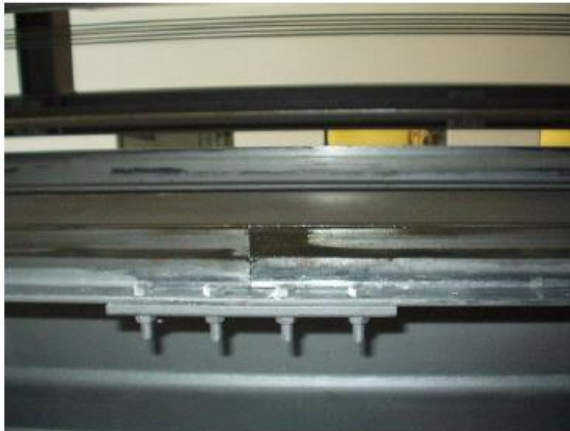
Vorhandene Schienenstöße am Gegengewicht waren nicht ordnungsgemäß verschliffen

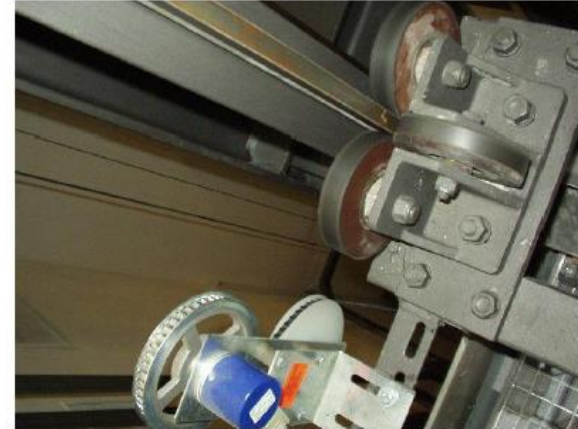
Quetschung der Mittel-Rolle durch fehlerhaftes Stichmaß (starker Lagerschaden)

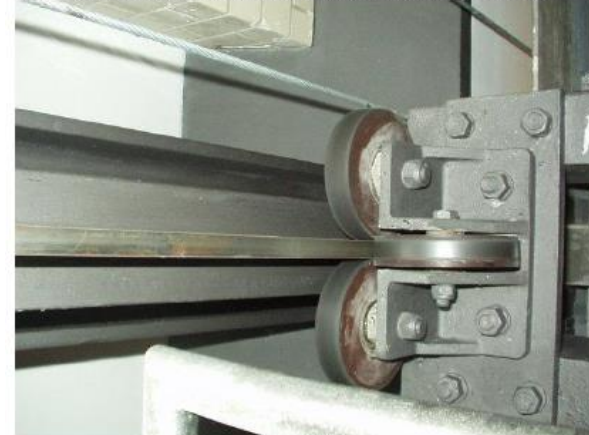
Starker Verschleiß des starr montierten 3-Rollen-Sets (Abrieb an der Mittel-Rolle)
